# **Technical Due Diligence**

China Assets

Prepared for China Everbright Greentech Limited

April 7, 2017

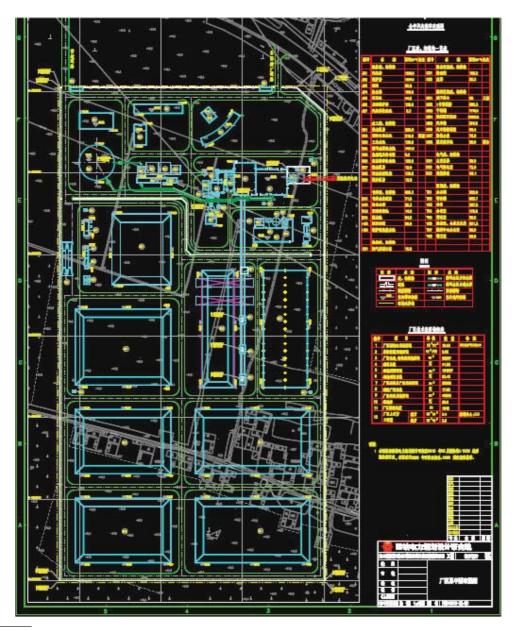
# Figure 2.1 Dangshan Biomass Plot Layout

Figure 2.1 shows the plot layout for Dangshan Biomass.

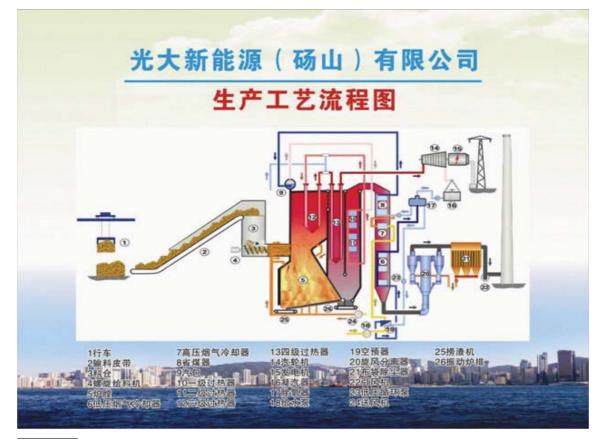
### **Figure 2.2 Simplified Process Flow Scheme**

Figure 2.2 presents a simplified process flow scheme for Dangshan Biomass.

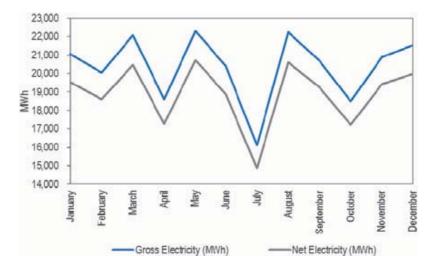
The electricity generated monthly is shown in Figure 2.3.

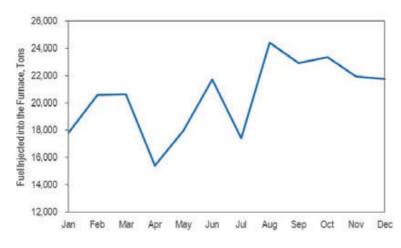
The biomass incinerated monthly is shown in Figure 2.4.

Nexant has not identified any issues with performance and availability.

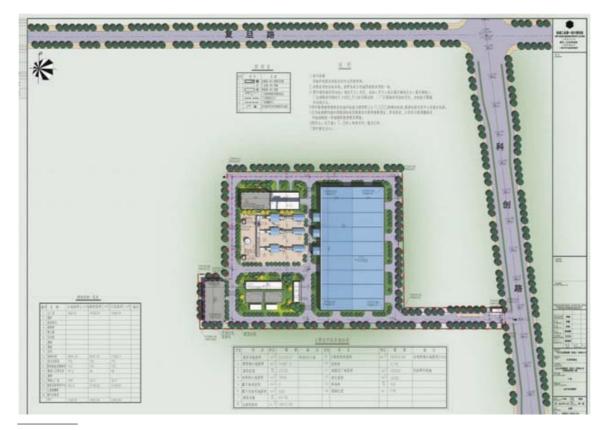
# Figure 3.1 Sucheng Biomass Plot Layout

Figure 3.1 shows the plot layout for Sucheng Biomass.

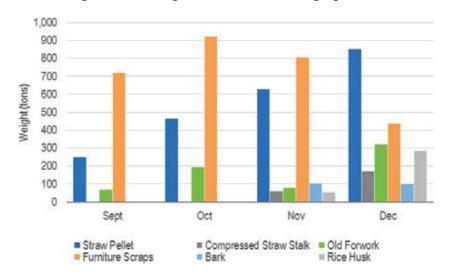
**Figure 3.3 Sucheng Biomass Sources during Operation**

A third party pellet quality test for heat value and moisture content is performed once every year. The May 2014 test was for the initial stage research. The most recent third party test was conducted on December 2, 2016 for rice husk. Each batch of biomass is tested internally to check if the results meet contract requirements. If not, Sucheng Biomass rejects the batch. For the months of September 2016 through December 2016 the biomass sources and their respective weights processed are shown in Figure 3.3.

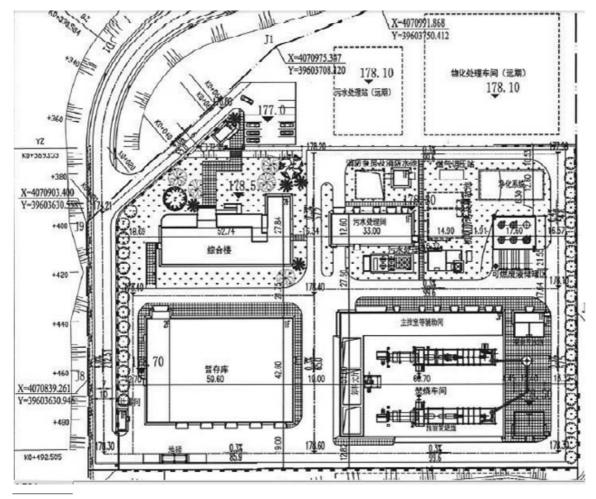
### Figure 4.1 Zibo Waste Plot Layout

Figure 4.1 shows the plot layout for Zibo Waste.

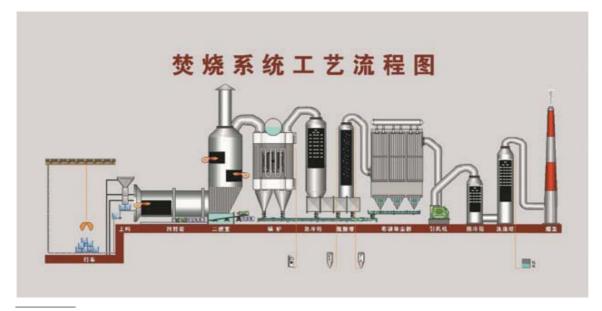
Figure 4.2 presents a simplified process flow scheme for the Zibo hazardous waste incineration system.

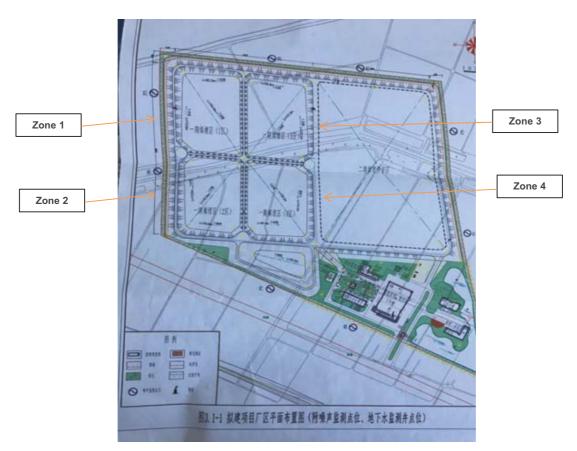
# Figure 5.1 Site Plot Plan — Guanyun HWL

The overall site plot plan is shown in Figure 5.1. The Guanyun HWL area is divided into four (4) equal zones. Currently, Zone No. 1 is operating.

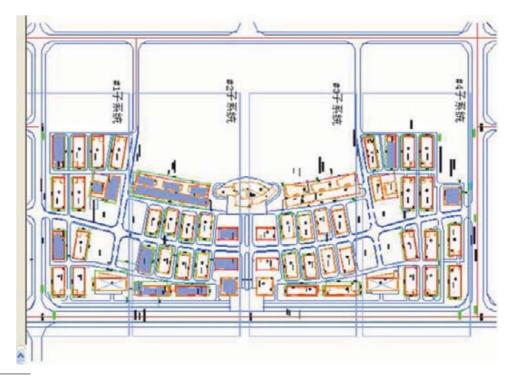
## Figure 6.1 Site Plot Plan for Zhenjiang Solar Facilities

The Company is operating the site located in an industrial park spanning over the rooftops of eight-one (81) commercial office buildings with site plot plan as shown in Figure 6.1. Zhenjiang Solar site started up in December 2011.

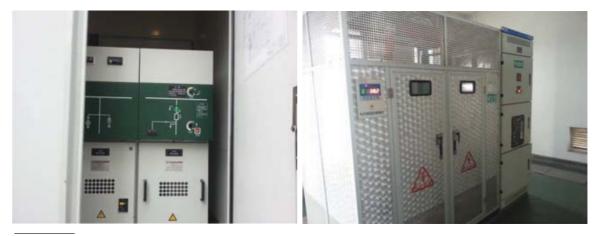
Nexant reviewed the technical data and information for the mechanical, civil and structural, and electrical design for the facility. Examples of major plant equipment are shown in Figure 6.3.

## **Figure 6.3 Examples of Site Plant Equipment** (*Typical Inverter and Electrical System*)

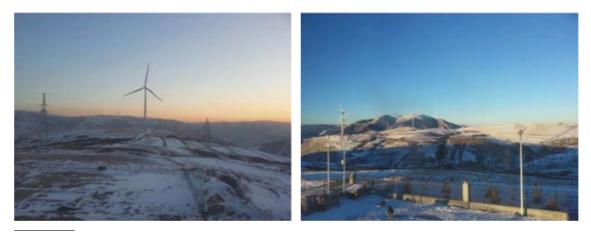
## Figure 7.1 Ningwu Wind Turbine Generators

Ningwu Wind facilities are located in Ningwu County, which is approximately sixty (60) km northwest of Xinzhou City in Shanxi Province. Ningwu Wind facilities, as shown in Figure 7.1, consist of forty-eight (48) total units of Gamesa G97 wind turbine generators. Each wind turbine generator has a rated capacity of 2.0 MWe and is connected via a 110 kV transmission line to the regional grid.

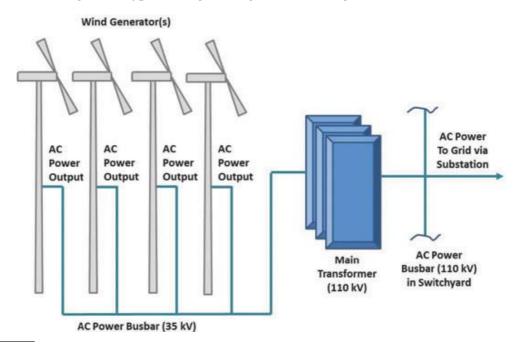
## Figure 7.2 Typical Design Configuration for Ningwu Wind Facilities

Nexant undertook a visual inspection and review of the plant and equipment conditions. Figure 7.2 is a schematic representation of the Ningwu Wind facilities operation.

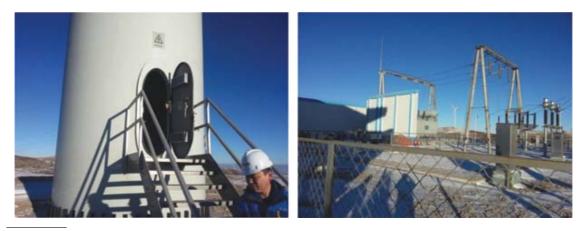
Nexant reviewed the technical data and information for the mechanical, civil and structural, and electrical design for the facility. Examples of major plant equipment are shown in Figure 7.3.

**Figure 7.3 Examples of Site Plant Equipment** (*Typical Wind Tower Structure and Power Switchgear System*)
